# **Appendix D**

## **Anomaly, Failure and Mishap Reporting**

In accordance with NSTS/ISS 13830, Payload Safety Review and Data Submittal Requirements, the AMS-02 Project has prepared this summary of anomalies, failures and Mishaps associated with flight and qualification hardware. This summary does not consider what are considered normal manufacturing deviations and discrepancies as failures or anomalies unless they rise to a clear safety impact status. All such manufacturing discrepancies associated with the AMS-02 Integration Hardware built and procured through Johnson Space Center are documented in the JSC QARC system.

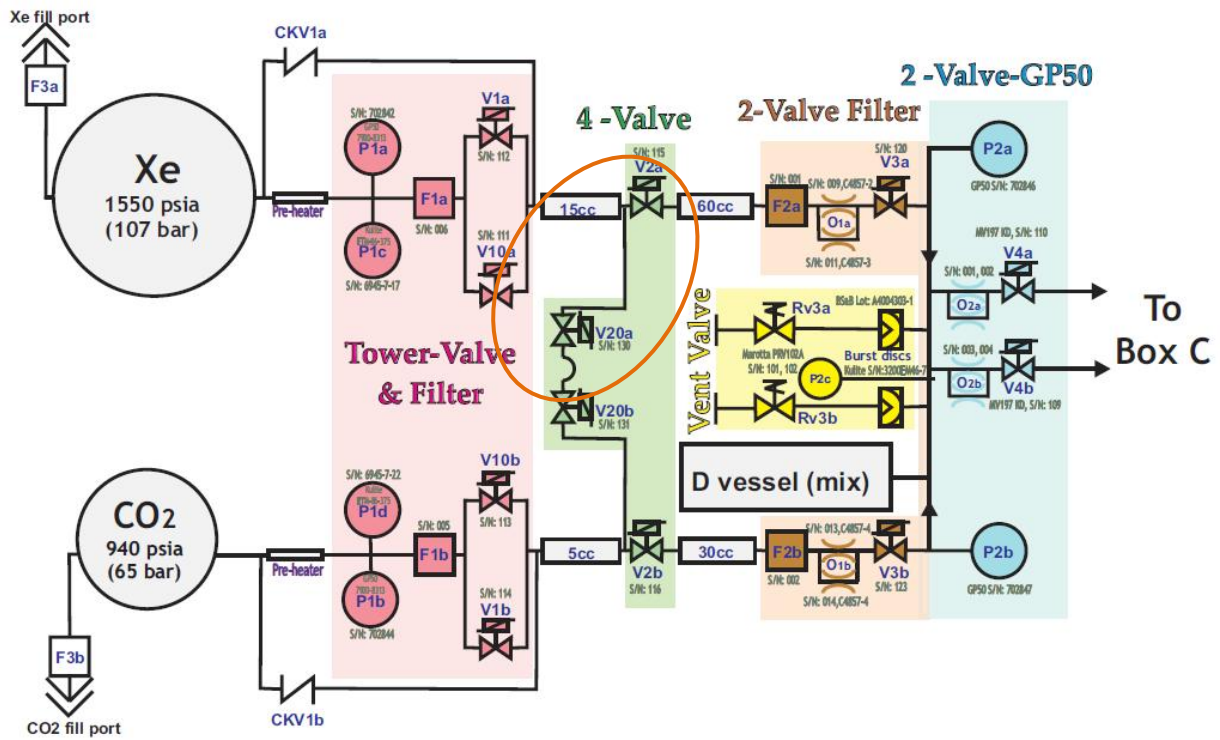
## Box S Schematic

**Description of Event:** During Thermal Vacuum Testing conducted at ESTEC, the TRD Xenon supply was found to have a very slow leak in one of the buffer volumes used in metering out the high pressure gas to the lower pressure (300 psi) portion of the TRD gas supply system. It was calculated that this leak would be inconsequential to the science and mission (take 57 years to leak out supply continuously) of the AMS-02, and the leakage of Xenon would be non-hazardous while on orbit or during ascent.

**Corrective Action:** Subsequent to the TVT the section of piping where the leak originated was located, cut out and a new section of pipe welded back into place. Due to the flight configuration, this corrective repair cannot be proof tested or even leak checked to MDP as there is no way to heat the Xenon supply to the maximum possible on-orbit environment that could generate the nearly 3000 psi of the system. The new welds will also be inspected with NDE to verify quality of weld. CERN inspection protocol 1078985-AMS is on file which validates the weld quality.

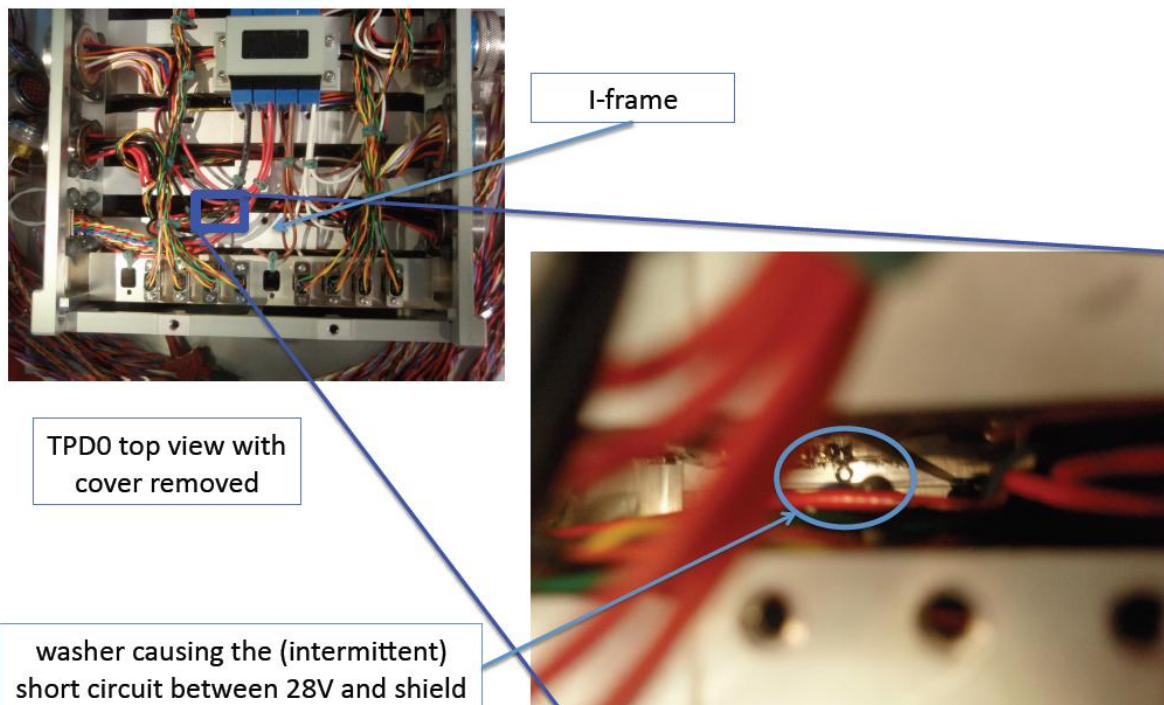
## problem identified

**Description of Event:** During Thermal Vacuum Testing (TVT) of the AMS-02 at ESTEC, the Tracker Power Distribution Box 0 (TPD0) never initiated operations. Throughout the entire TVT procedures this box was non-operational. Upon deintegration and opening of the box, a flat washer was found to be wedged inside the box and shorting the power feed into the unit.

**Corrective Action:** Washer was removed and the box underwent additional testing to locate possible alternate sources of problems or damage as a consequence of the washer's presence. Testing indicated full functional return after removal of washer. The washer appeared to be surplus to the construction of the TPD0 box.

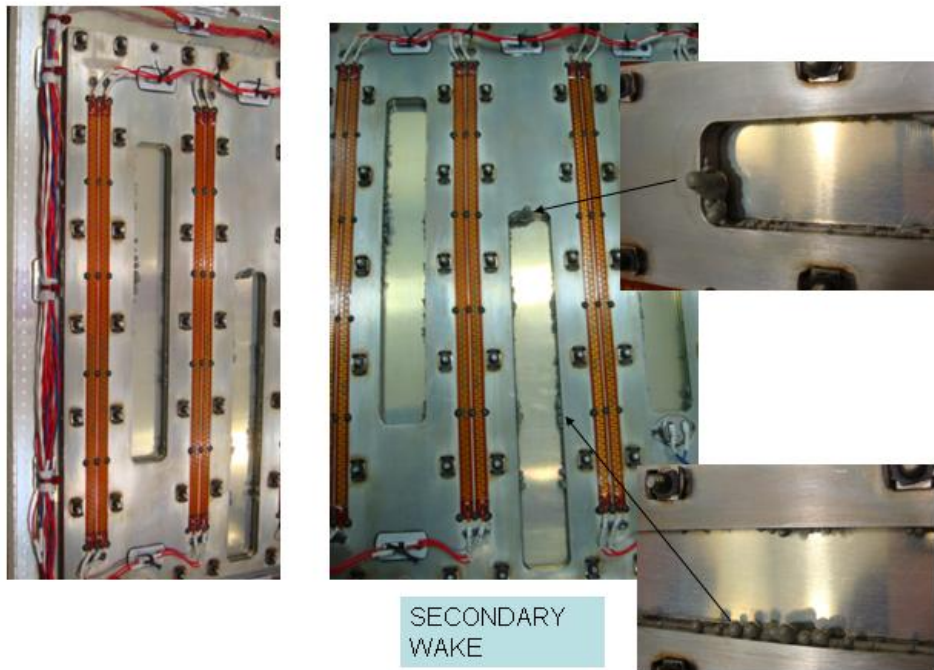
**Description of Event:** Subsequent to the Thermal Vacuum Testing (TVT) of the AMS-02 at ESTEC, the one of four TTCS Condenser to TTCS radiator interface thermal epoxy material Chotherm 1671 was found to have flowed from the interface to the edge of the interface and accumulated there. The Secondary Wake condenser showed some glue bubbles outflow. This condenser has been operated (in vacuum) between  $-65 \sim +30^{\circ}\text{C}$ .

Suspect cause for the glue coming out from the edge is a wrong mixing ratio on the component A and B for the MASTERBOND EP21TDC- 2LO. In fact, the glue has been applied in different steps (4 days) and the out flowing is localizing only on the layer between top and bottom plate, meaning that the connection between tubes and bottom plate, performed on the first day, has been not affected. The glue is also visibly soft, meaning that a complete cure was not achieved.

The condenser performance is therefore not affected. The only affected thermal connection is between top plate (with heaters) and the tubes. However defrosting was shown to be successful during TV-testing.

- Verify if the spilled glue can be cut without damage the edge of the aluminium plate and without pulling out glue that is still inside the bottom and top plates.
- Take a sharp knife and remove all the spilled glue all around the edges on the secondary wake condenser.
- Tape will be attached to the sides of the crosscut ends of the condenser to contain the glue particles. This measure is in addition to the MLI wrapped around the back side of the Tracker radiators. Tape: Chofoil ccj-36-201-0100

- In view of the limited spill glue and the impossibility to add glue or replace the condenser, no action is taken. Worst case impact is a larger RC-time to de-freeze the condensers on orbit.

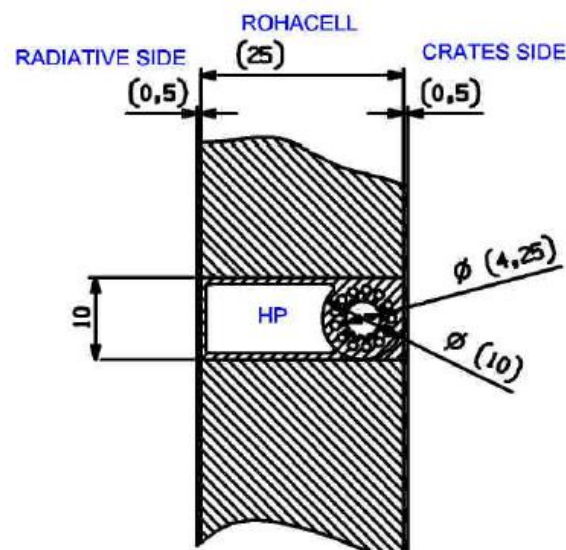
**Main Radiator Cross Section**

0.5 mm sheet of 2024-T81 aluminum face sheets bonded to 25 mm thick ROHACELL® 51WF core.

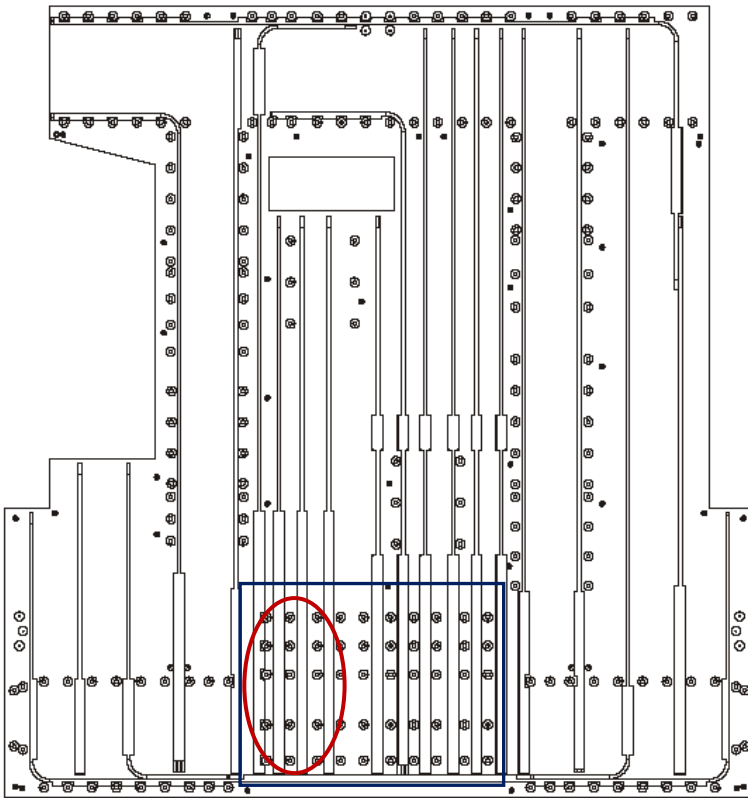
**Description of Event:** Upon deintegration of the PDS Avionics box from the WAKE radiator in preparation for conversion of the AMS-02 to utilize the Permanent Magnet at CERN, one section of the aluminum skin was discovered to have undergone a corrosion event which left “worm tracks” upon the skin. This corrosion occurred on one side of the junction of two skins where the avionics box covered the material from both skins. Only one side (skin) experience corrosion while the other side did not. The investigation has led the reviewers to believe that during the brush alodining process for this region the one skin was not sufficiently rinsed after the process was completed (each skin was alodined separately) and the Chocterm retained moisture that was present as a consequence of the cryogenic servicing (not directly on the region, but higher than expected humidity, held by the Chocterm) that led to the localized corrosion event.

(left) WAKE Radiator Layout. The approximate location of the Corrosion located in the Red outlined zone.

**Corrective Action:** The area that experience corrosion was cleaned of all surface corrosion and the area was brush alodined in accordance with Manufacturer’s Instructions. The removal of the Cryogenic system will eliminate the condensation of moisture from the atmosphere in the proximity to the box. This has been accepted as a strong contributing factor in the generation of the corrosion.

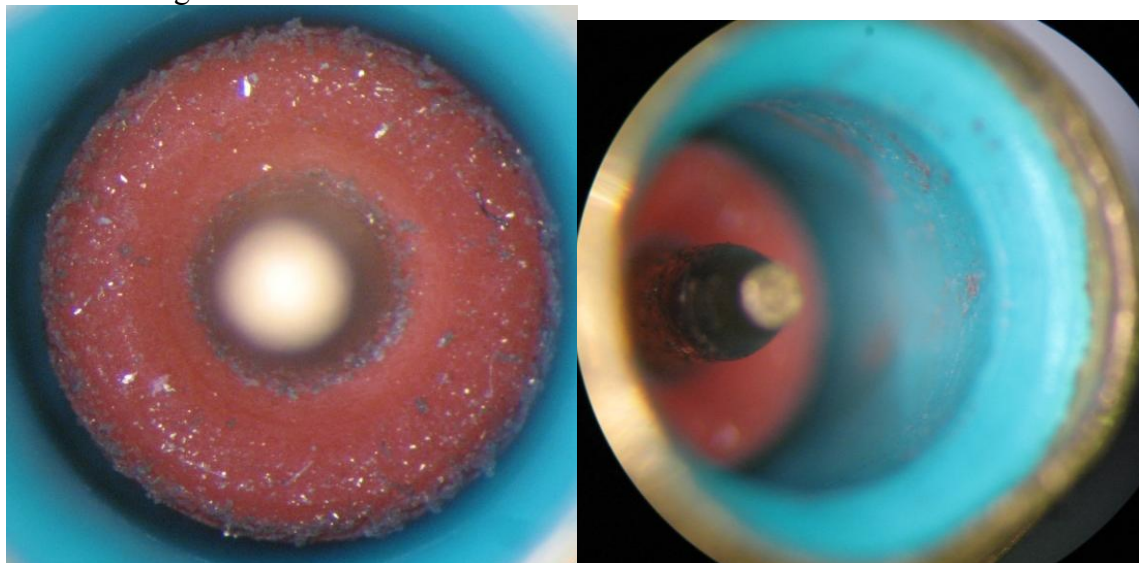
**Description of Event:** During deintegration and reintegration of HV cables that had to be demated to support the exchange of the Cryomagnet System with the Permanent Magnet System, tiny particulates of gold, flecks, were detected in the interior of the connectors.

Example of gold fleck debris

After cleaning connector with Manufacturer's Process

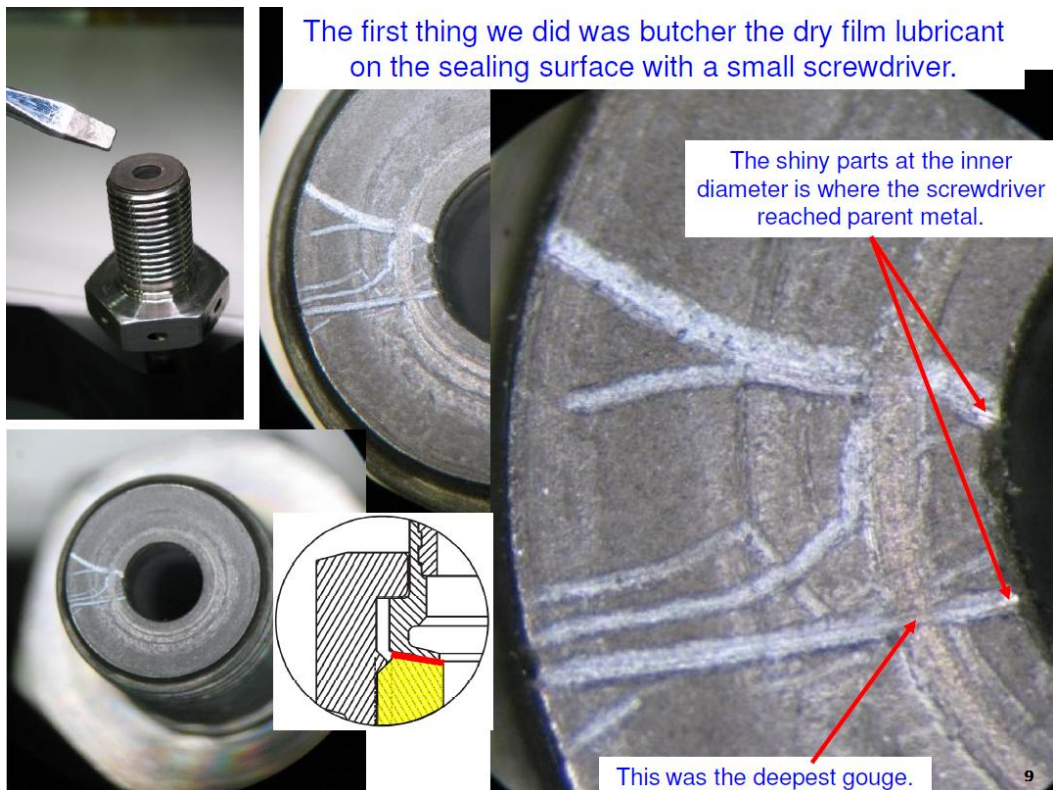
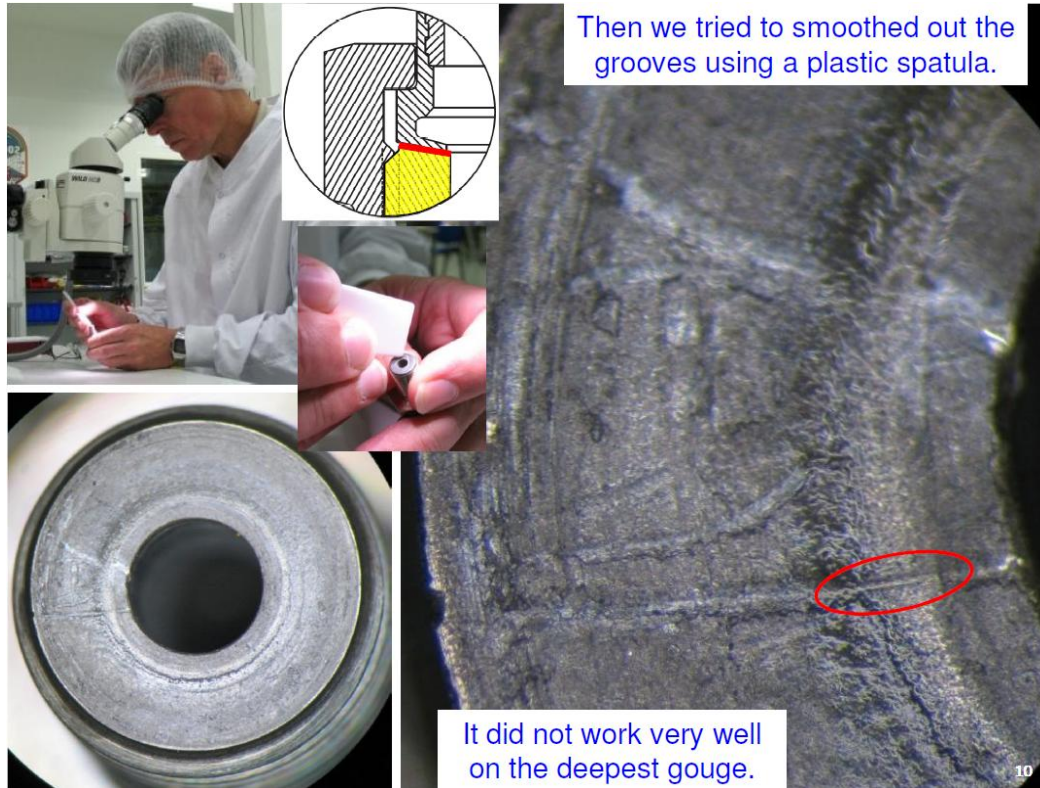
Testing repair methodologies

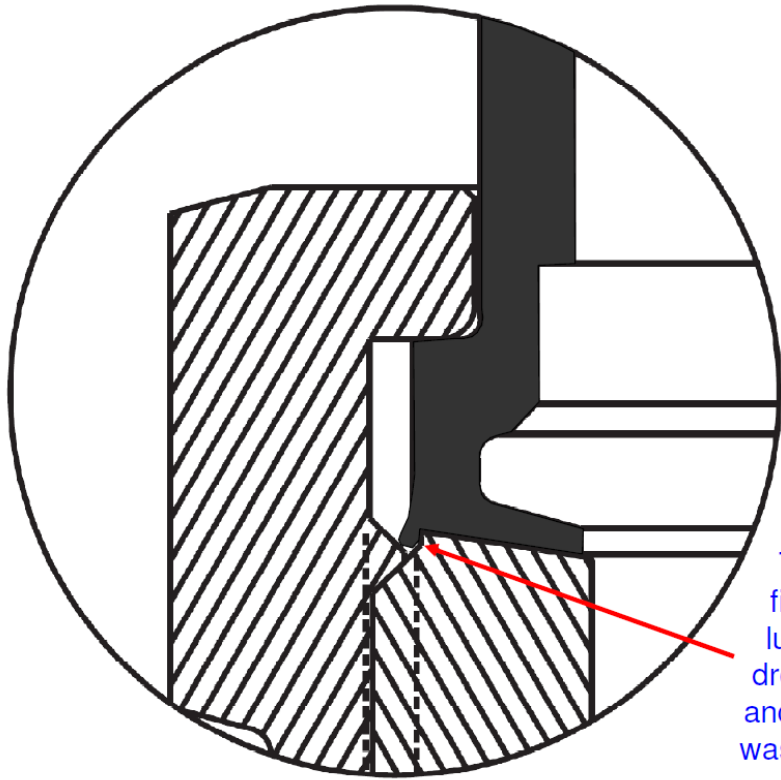
Explanation of center piece sticking after “overtorquing”

The lower half of the fitting with the dry film lube and male threads drove into the upper half and as it yielded, material was pushed outwards into the threads.
